Sanitary Survey Report

**Polacca, Arizona
PWSID #0400106**

Survey Conducted on April 7, 2014

**Sanitary Survey
Polacca
PWSID #0400106
Survey Performed April 7, 2014**

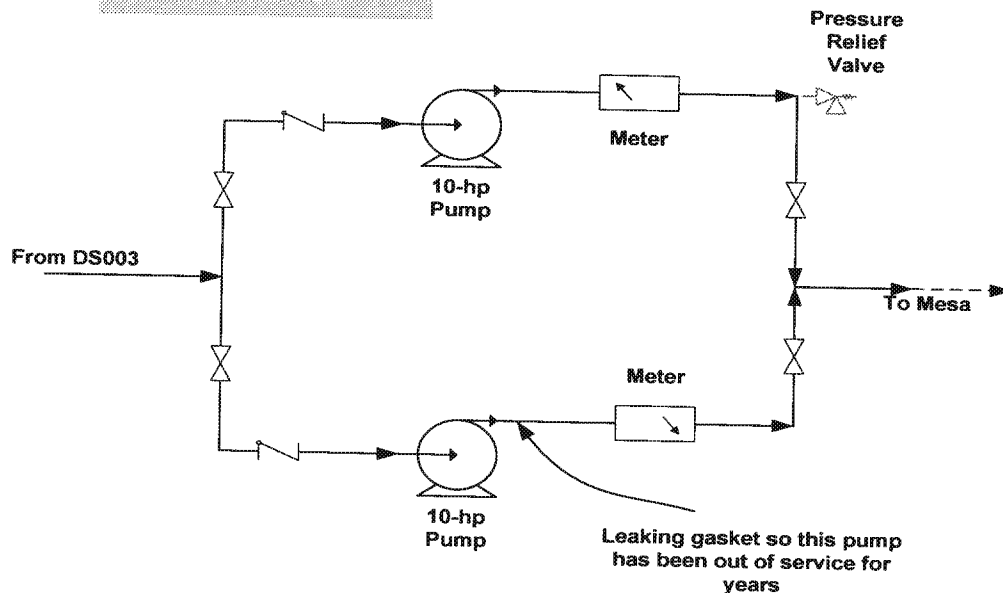
PF001

Controlled by One of the pumps has been out of service for years without correction. Apparently, it only needs a small and inexpensive part to stop a leak.
The operational pump runs on a timer which causes the tank on the mesa to overflow at times.
